GENERAL DESCRIPTION:

The inspected property consisted of a two and half story wood-framed structure with *brick veneer and stucco siding* that was occupied at the time of the inspection. The age of the home, as reported by the real estate agent, was said to be 10X-year-old (192X).

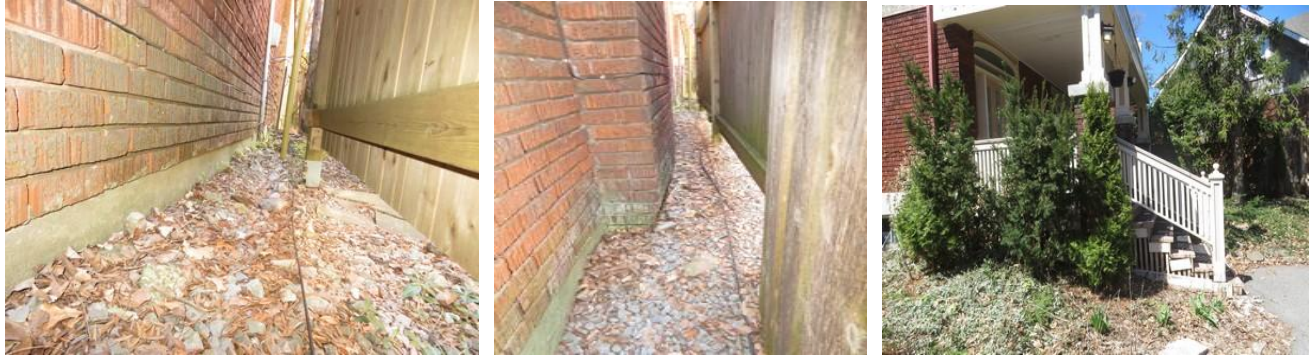
The home was situated on a level lot. The general grade around the home appeared to be adequate to direct rainwater away from the foundation. The front and backyard of the house were covered with bushes and vegetation/climbing vine. It is recommended to trim or remove the bushes, vegetation and vine to prevent it from covering soffit vents and damaging siding and windows.

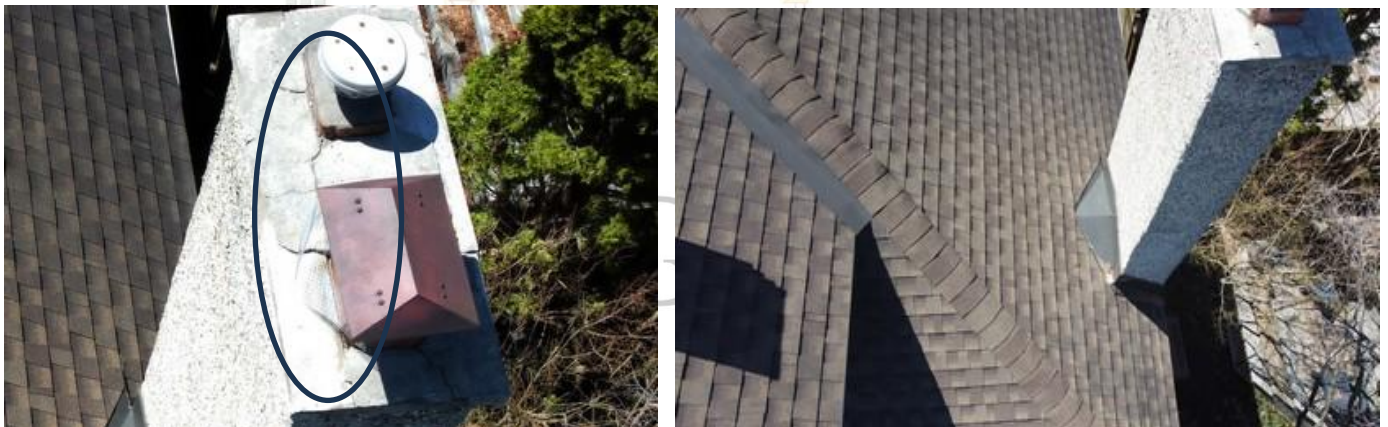
There were visual indications of loose mortar on the chimney top. Contact licensed contractor for further evaluation and repair. The bird mesh from one of the chimney outlet was out of its place. The absence of bird screen allows birds or other small animals to penetrate into channels.

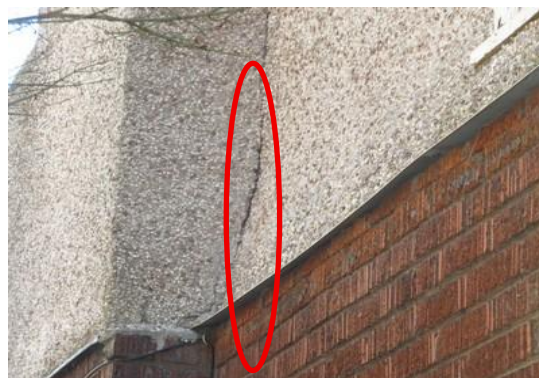
Cracks were observed on the exterior side of chimney unit separating away from the structure. It is recommended to caulk the joints to prevent penetration of water inside the structure.

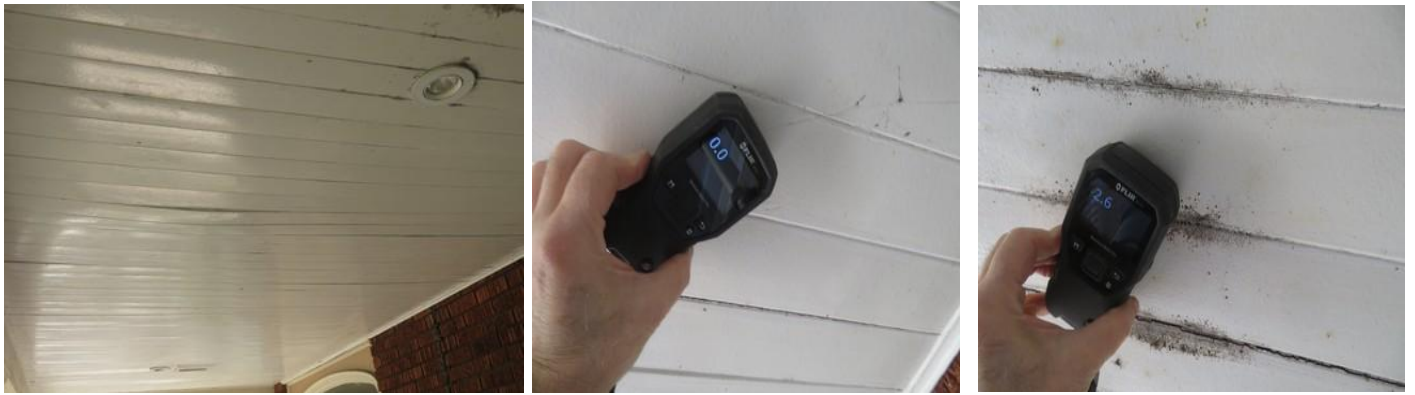
A bow with signs of mould was observed under the front deck ceiling. Moisture was tested with moisture meter which was within the limits.

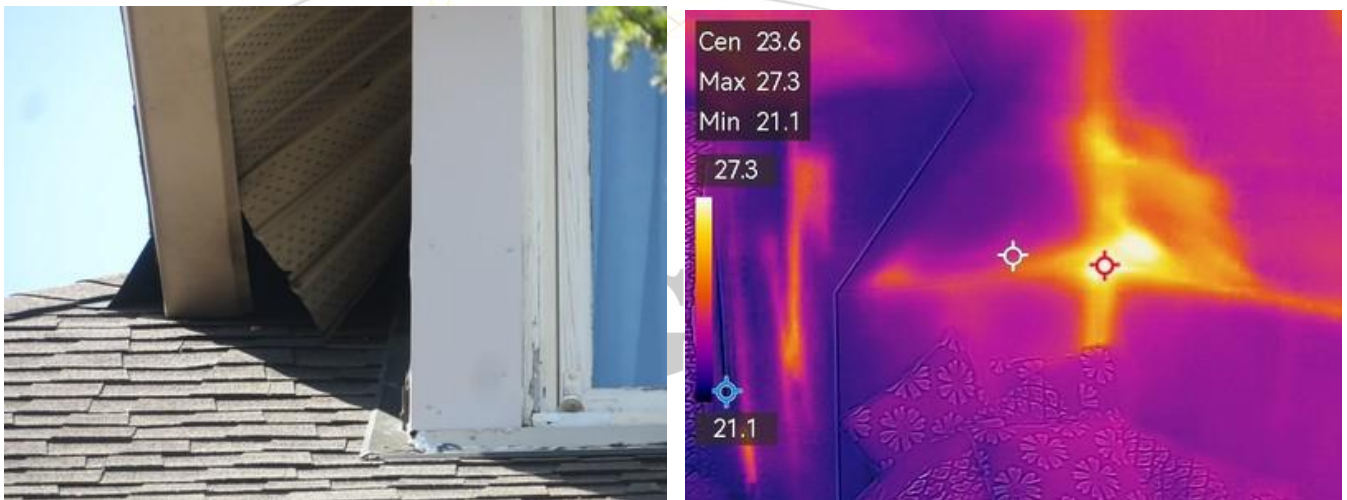
Soffit boards at the top left corner of the house **was damaged and formed a gap**. The gap should be repaired to prevent animals or birds from penetrating to the attic. Thermal image from inside the top room shows thermal leakage, primarily due to damage to the insulation inside the attic.

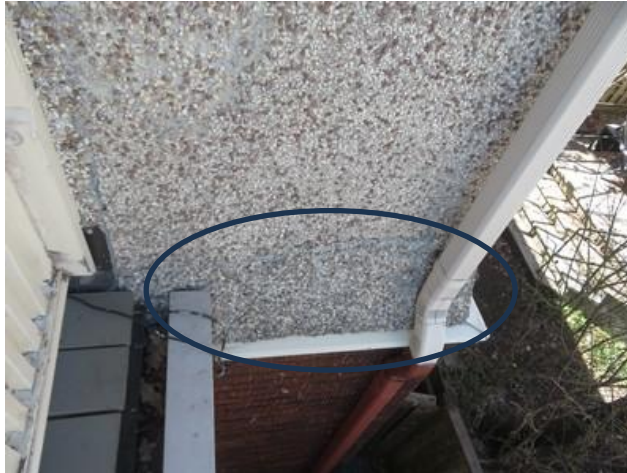
Hair line cracks were observed in the the stucco at various locations. It is advised to caulk the cracks to prevent penetration of water into the structure. There were no major visual defects on the visible portions of the siding.

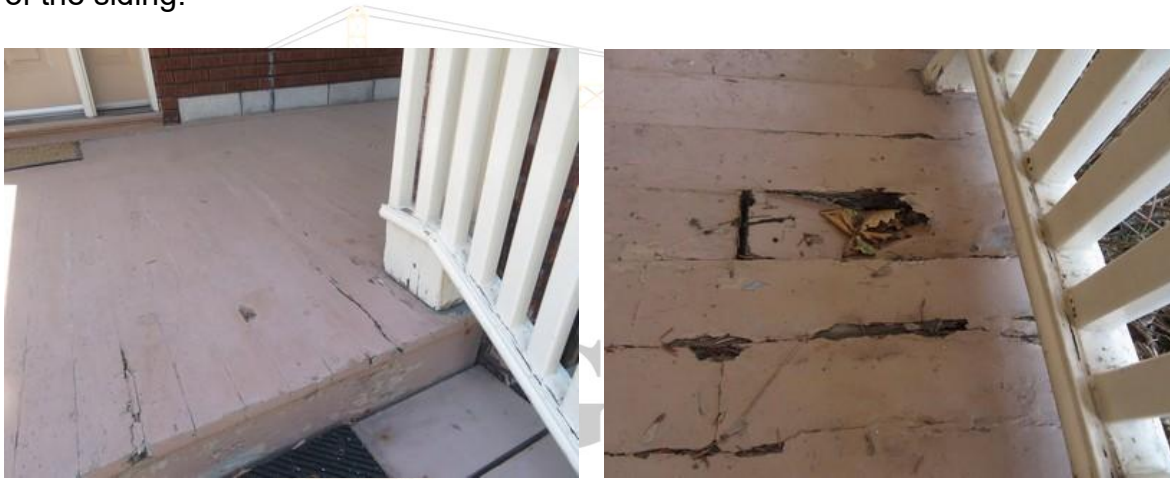
Monitoring for potential wood decay and instability of deck structure is advisable.

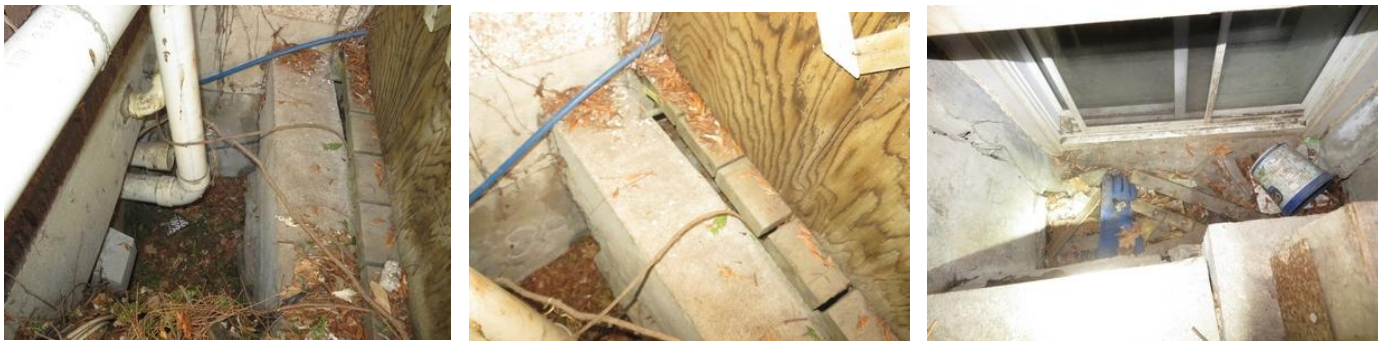
The concrete window wells appeared to be broken/cracked. Damaged window wells can lead to flow of water into the basement windows or movement of soil into the wells thus blocking the weeping tiles drainage system.

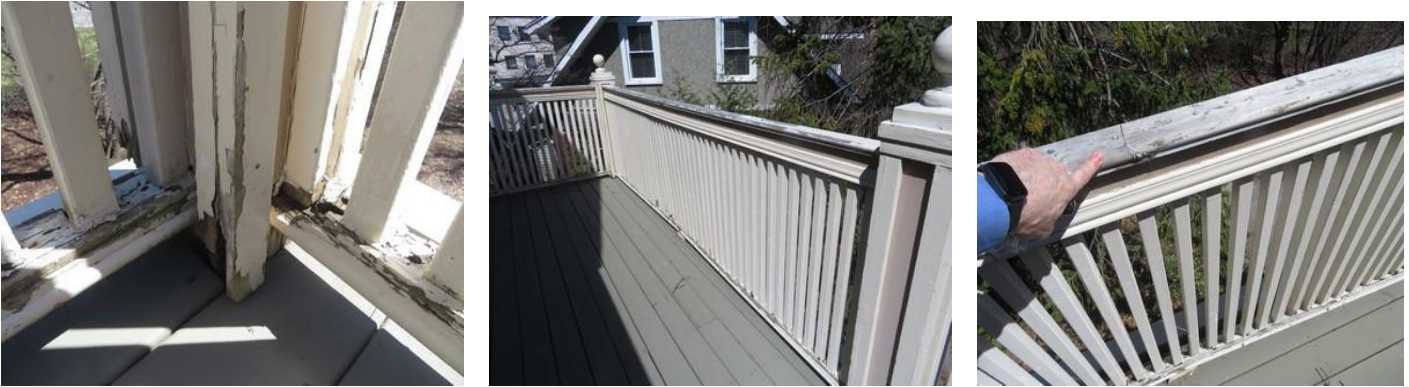
Signs of wood rot and deterioration were observed on the handrails of the deck. One of the span of handrails was longer than 6 feet and without the post in between it.

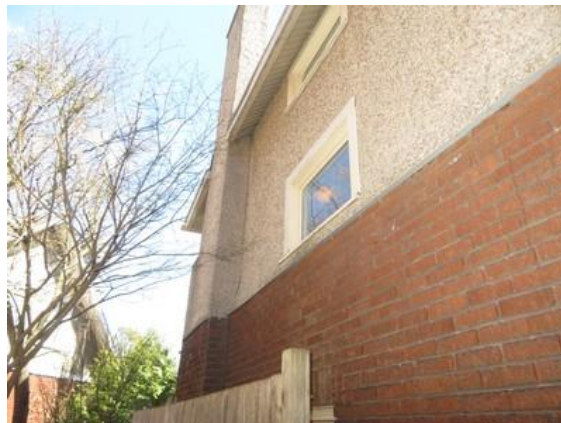
There were no gutters on the right side of the roof.

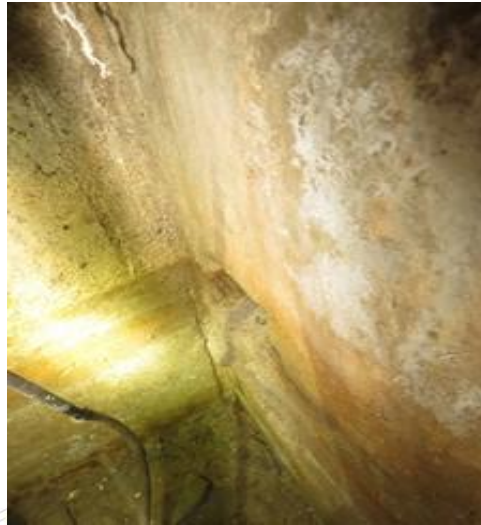
The foundation was constructed of **large aggregates poured foundation also known as "Poured concrete rubble foundation"**. There were **signs of deterioration and erosion** observed on the small visible portion of foundation (near sump pit). Due to the age of this type of foundation, it is very likely that some flaking of the mortar has occurred.

But the exposed wall area was generally in **satisfactory condition**. There was no sign of shifting or settlements, cracks and holes did not appear to have structural significance at the time of inspection. **Given its age, the foundation appears to be in satisfactory condition.**

(Exterior inspection alone is inconclusive and the interior foundation walls should be thoroughly inspected for cracks that extend from the outside.) Note that an inspection cannot be conclusive on Basement / foundation walls that have interior finishing, insulation or interior parging.

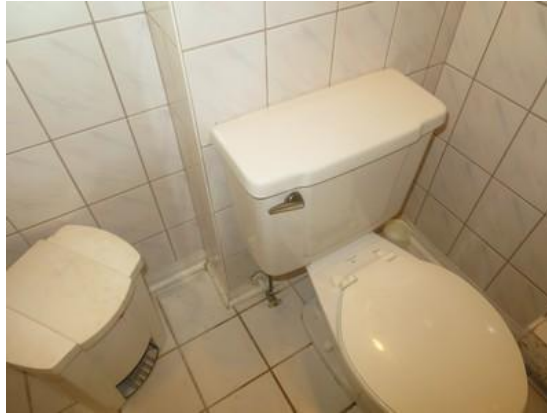
Main sewer cleanout was not found, it appeared to be behind the bulkhead in the basement bathroom. Verification and installation of access door is advisable.

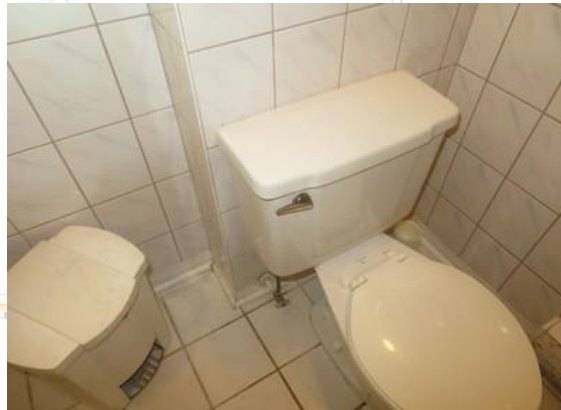
The flushing crank for the toilet in the basement was not working properly. Consulting a licensed plumber is advised.

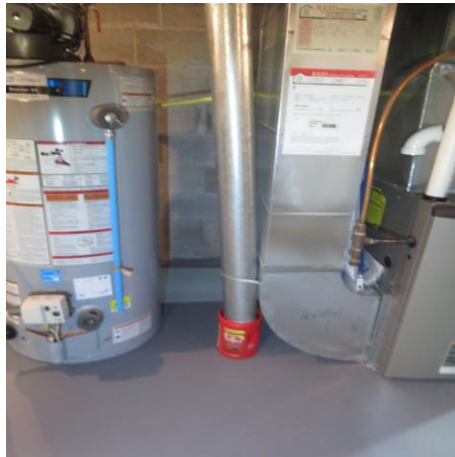
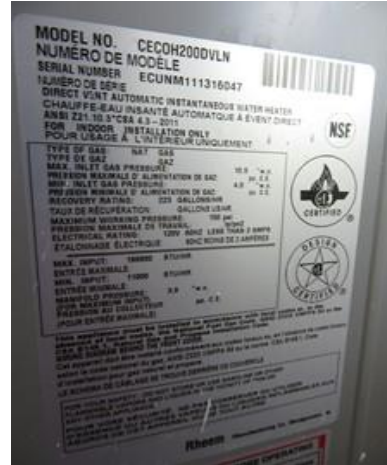
There was an owned, 50 gallon gas **water heater** located in the basement. The water heater was manufactured by Rheem. Information on the water heater indicated that it was manufactured 13 years ago. **Theoretical life expectancy for natural gas water heaters is approximately 12-15 years. Inspection by License Plumber and possible replacement is recommended.**

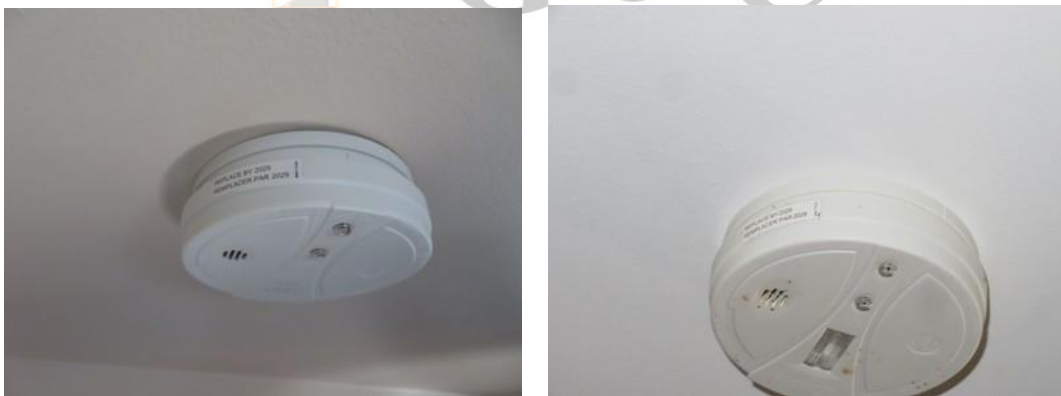
There was functional battery operated smoke alarms found in the house. **For safety reasons, the smoke alarms should be installed in all levels of the house and tested upon occupancy.** The batteries (if any) should be replaced with new ones when you move into the house and tested on a monthly basis thereafter. No smoke alarm was observed in the basement.

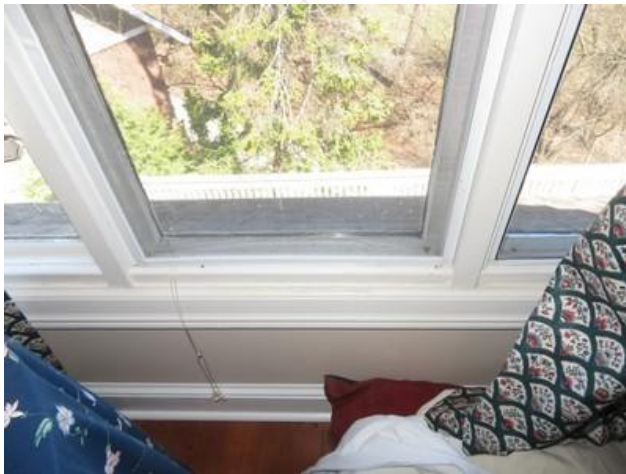
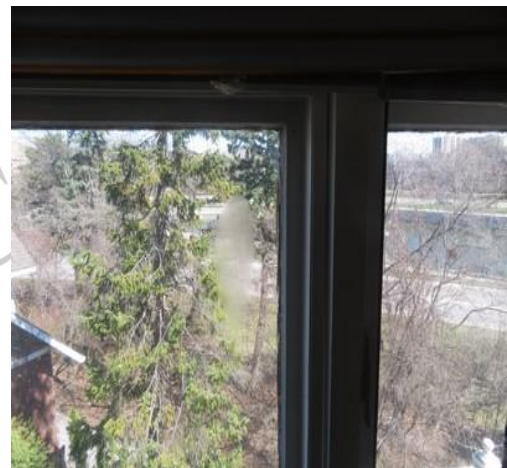
Some of the windows started showing signs of seal deterioration, which leads to condensation inside the windows. The original insulated windows should be monitored and replaced/repared in the future. *Contact Window Company for estimated cost of glazing units' replacement or repair.* All exterior doors were operated and are found to be functional.

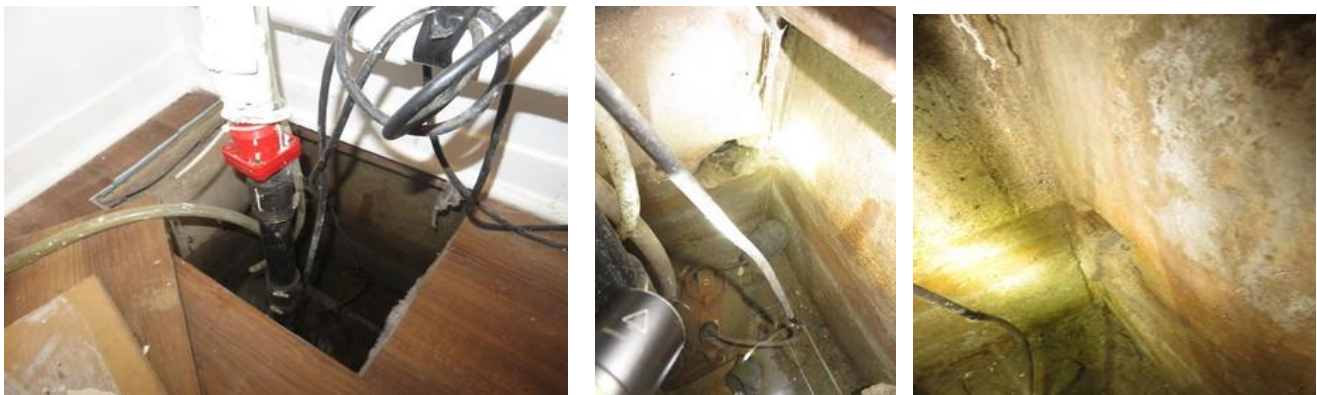
There was a sump pump located in the sump pit in the basement and was connected to house weeping tiles that run into the sump pit. The sump pump discharge pipe appeared to be discharging below soil level outside to an unknown location. Verification is advisable. There was check-valve installed in the drainpipe. The **sump pit's cover** shall be installed in a fashion when it would resist possible **removal by children**. Contact Licensed Plumber for routine inspection.

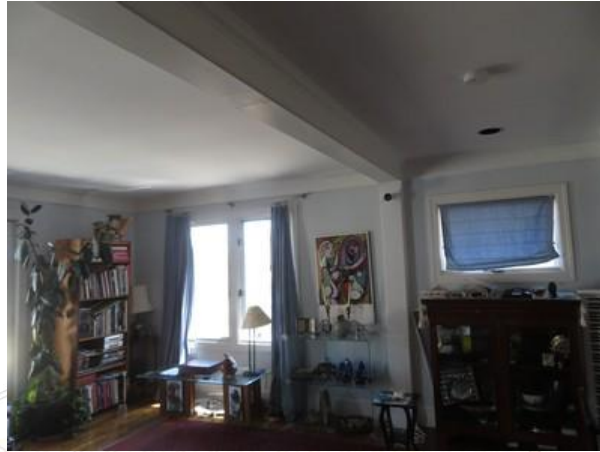
There were signs of structural changes in the living area in the past. It is advised to keep a copy of building permits.

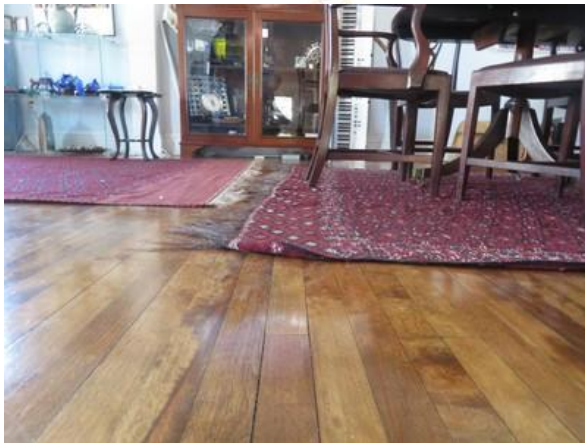
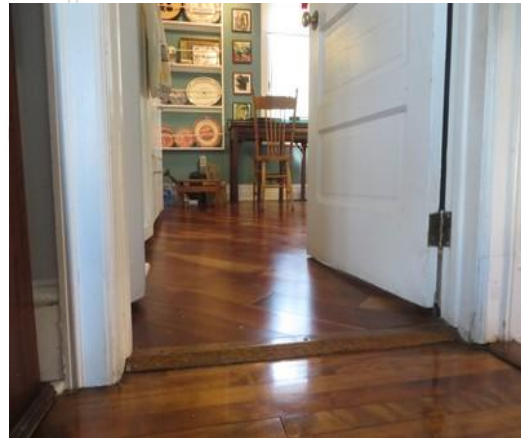
The floor of the living area and the kitchen was observed to be out of level and sloped in one direction.

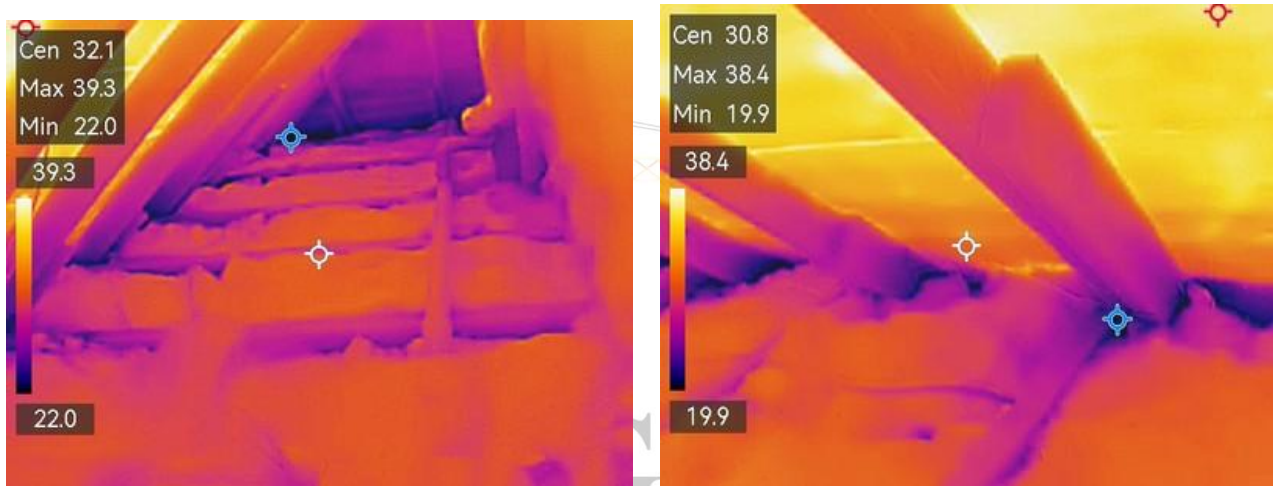
There was insufficient ventilation in the attic - **not enough intake capacity**. There were some areas on the back portion of the attic where **air channels from the soffit were blocked** by insulation. These air channels should be open for air circulation. (Regular snow removal in winter time and installation of baffles is advisable.)

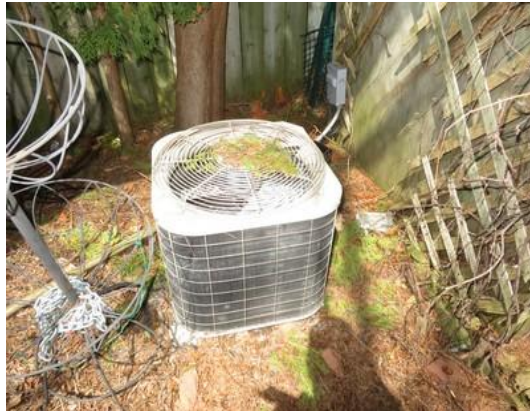
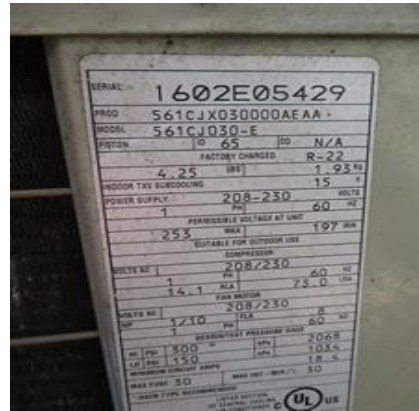
The unit is located on the back side of the home. The unit is approximately 24 -year-old. Periodic preventive maintenance is recommended to keep this unit in good working condition. Theoretical life expectancy for Air Conditioner is approximately 12-15 years. Inspection by License HVAC Technician is recommended before occupancy. Replacement is advisable.

The condensing unit was **installed on the soil** (there was no visible support) and **was positioned on the ground level**, which will cause water penetration and premature deterioration. The control wires and pipes were partially buried underground. The condensing unit should be raised above the ground level and installed on the proper support and its pipes and wires must be run above the ground as well.

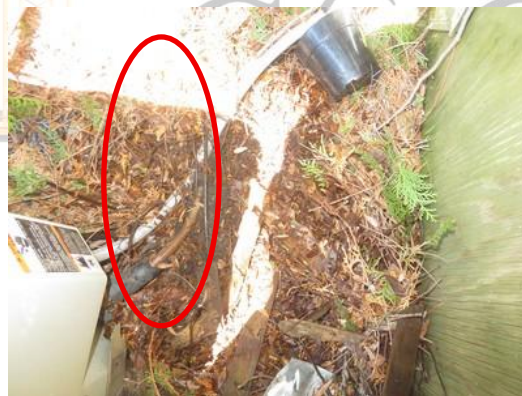
The insulation on the suction line and return line of the A/C unit was missing. Restoring insulation is recommended.

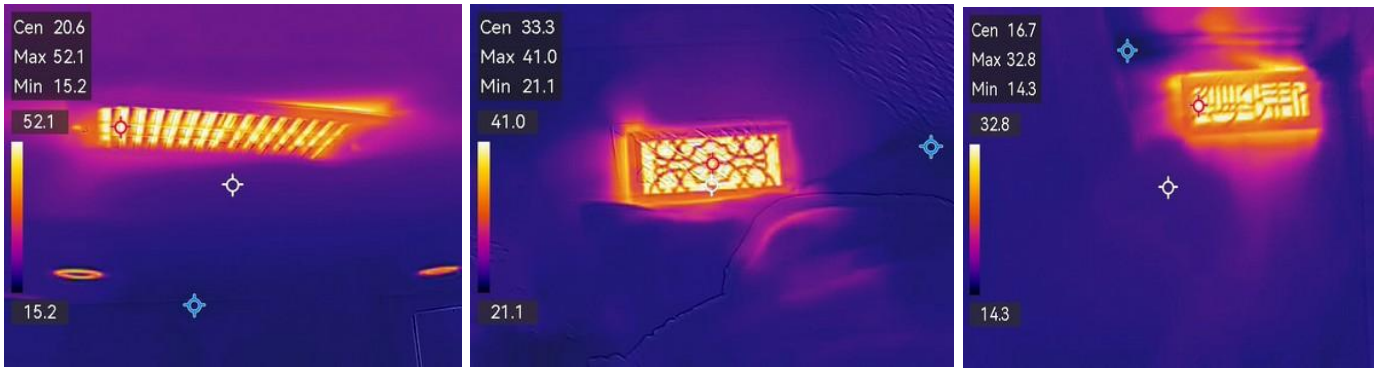
There was *no cold air return duct* in the basement. Recommend installation of a cold air return duct in the basement to promote normal air circulation.
