GENERAL DESCRIPTION:

The inspected property consisted of a two and half story wood-framed structure with *brick veneer and stucco siding* that was occupied at the time of the inspection. The age of the home, as reported by the real estate agent, was said to be 10X-year-old (192X).

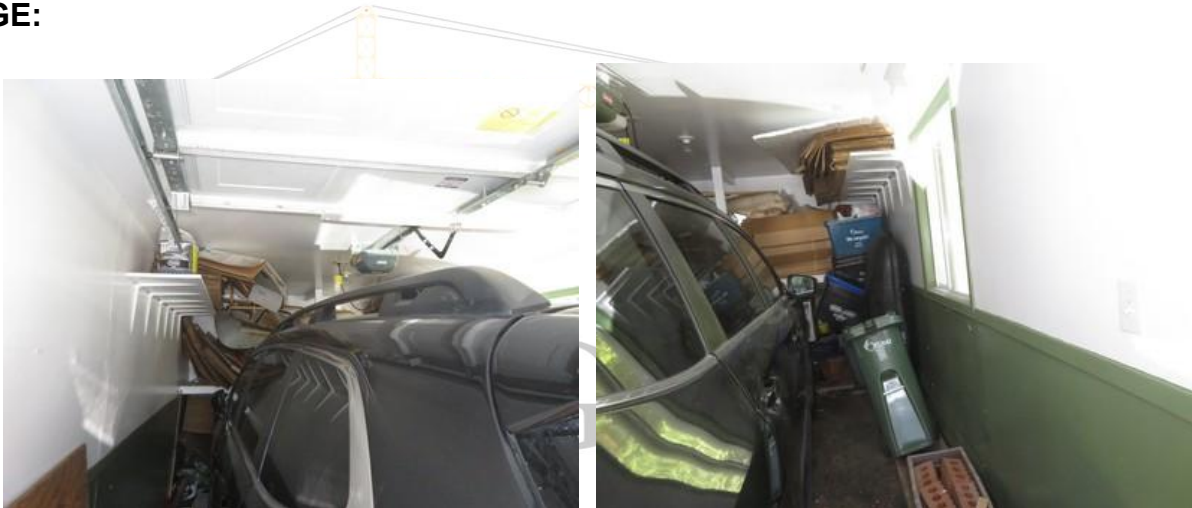
GARAGE:

The detached garage was designed for one car with access provided by one overhead-style door. *Store items obscured most areas of the garage floor and walls.*

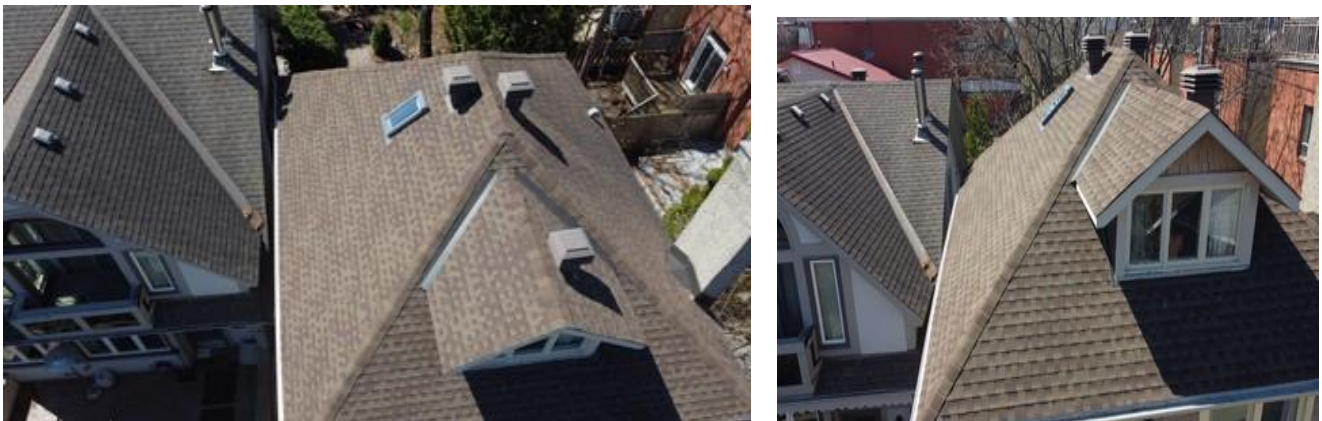
ROOF STRUCTURE:

The roof was a gable design covered with architectural shingles. Observation of the roof surfaces and flashing was performed by drone camera. The age of the roof covering, as reported by the owner, was six years.

There were no curling and no surface wear observed on the visible portion of roof shingles at the time of the inspection. These conditions indicate the roof shingles were in the first half of their useful life.

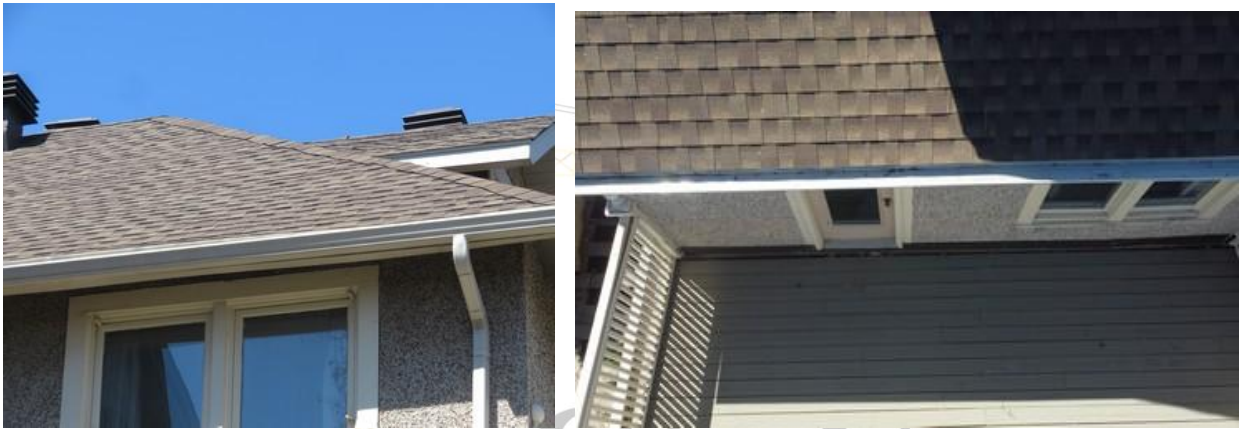
The **roof drainage system** consisted of aluminum gutters and downspouts, which appeared to be functional. Gutters and downspouts should receive routine maintenance to prevent premature failure. The flat deck on the first level had separate drainage system.

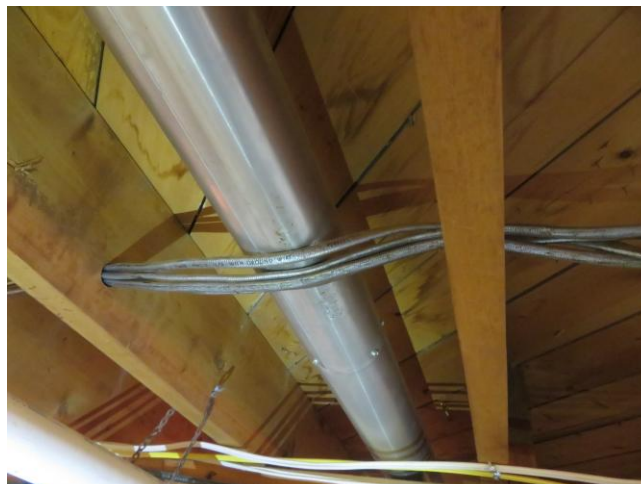
FLOOR STRUCTURE:

The visible floor structure consisted of a wooden plank subfloor; supported by two-inch by eight-inch wood joists spaced sixteen inches on center.

There were no major visual defects observed in the visible portions of the floor.

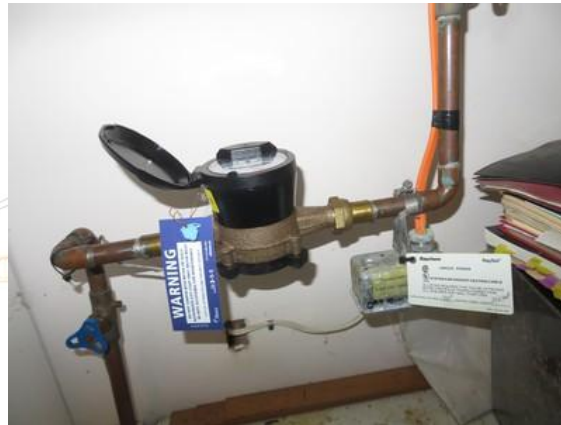
PLUMBING:

The visible water supply lines throughout the home were copper pipe. The water was supplied by a public water supply. The visible waste lines consisted of ABS Plastic. The home was connected to a public sewer system.

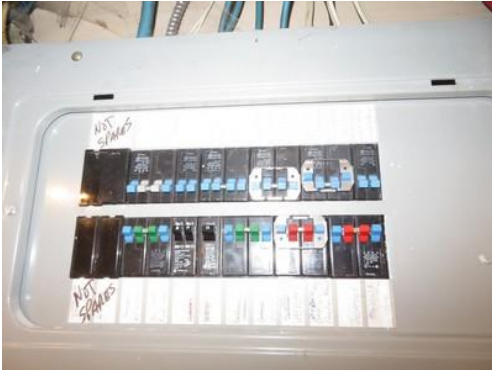
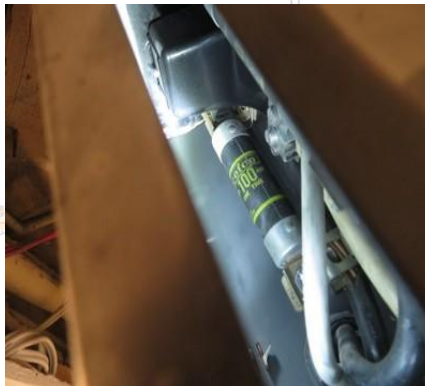
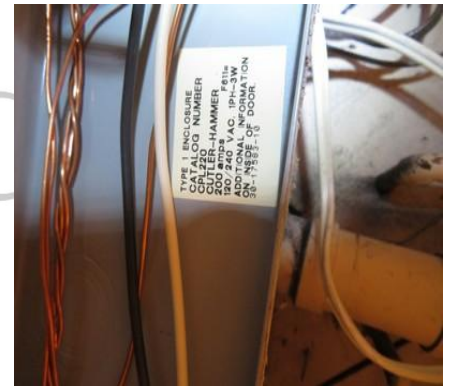
ELECTRIC SERVICE:

The electric meter was located near to electric panel inside the basement with disconnect of 100 amps capacity. The service wire entered a "CUTLER HAMMER" multi-functional service panel, located on the basement wall with 200 amps and 120/240 volt rated capacity. The branch circuits within the panel were cooper and the house wiring was mostly cooper. These branch circuits and the circuit breaker to which they were attached appeared to be appropriately matched. The visible house wiring consisted primarily of the old and new Romex type and appeared to be in fair condition.

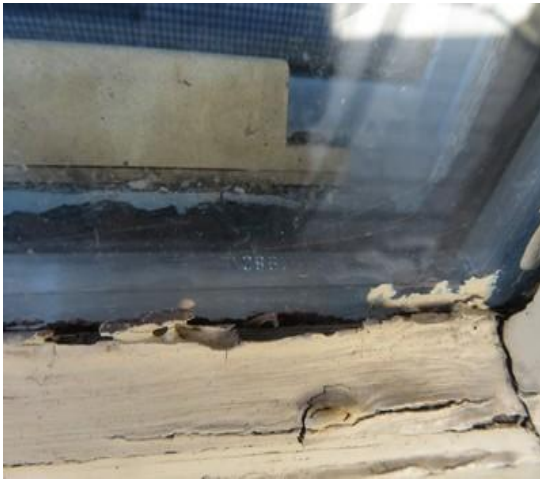
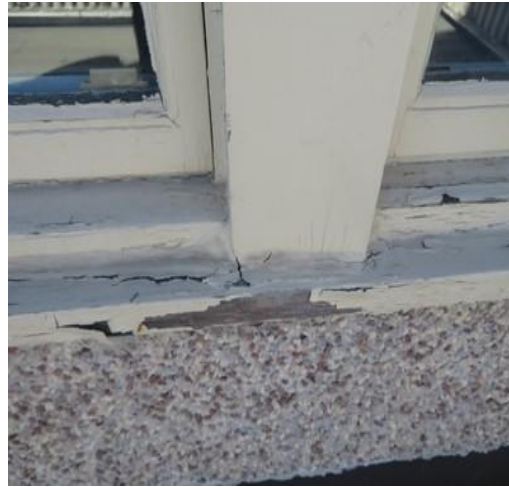
A number of accessible windows and doors were not operated due to their age and paints on the hinges and thus their functionality cannot be checked. The primary windows were constructed of wood framed- side hung casement style with insulated glass manufactured in 1984.

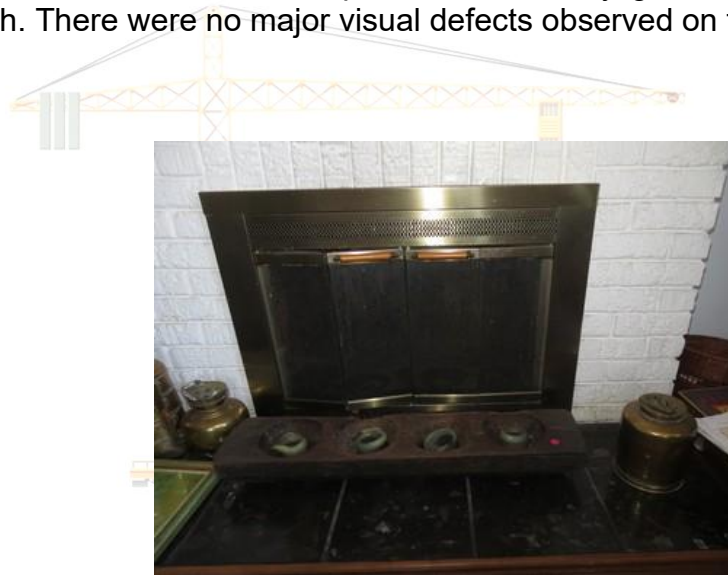
FIREPLACE:

A wood-burning fireplace was located in the family room. **For safety reasons, a fireplace and the chimney or pipe to which it is vented should be cleaned and re-inspected by WETT certified technician as there may be hidden defects, not fully visible at the time of the inspection.** The fireplace was not tested for operation or function.

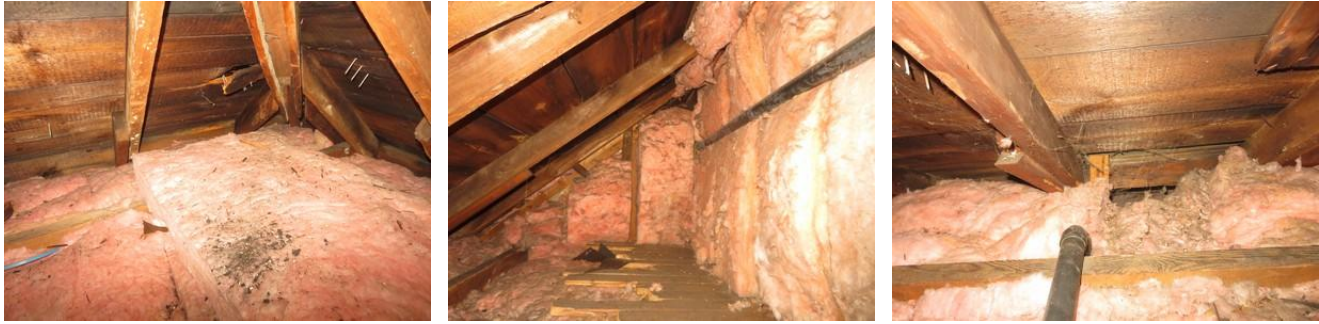
The attic was accessed through a kneewall hatch on the top floor. The attic space was insulated with fiberglass insulation (variable thickness), Ventilation throughout the attic was provided by soffit and roof vents.

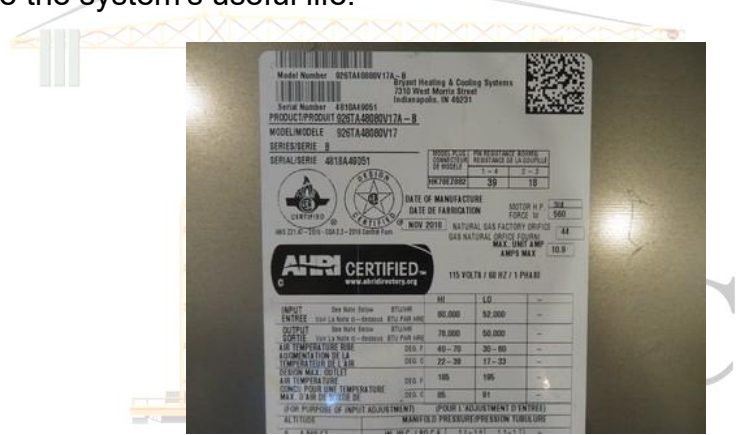
The results of our visual and operational inspection of the heating and air conditioning system are described below. Periodic preventive maintenance is recommended to keep this unit in good working condition. The home was heated by "Bryant" natural gas high efficiency forced air furnace, that is 8 years old. The unit was located in the basement of the home.

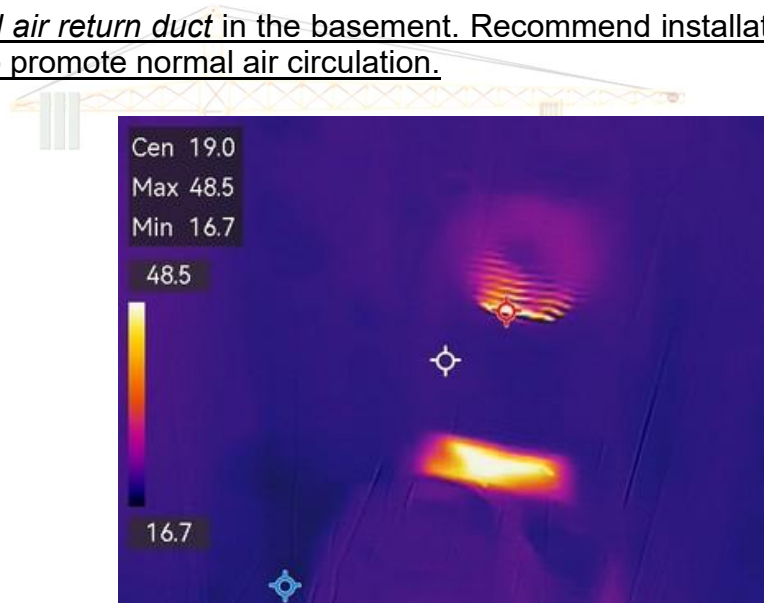
The foyer has unit space heater installed in addition to HVAC duct, which appears to be operational.

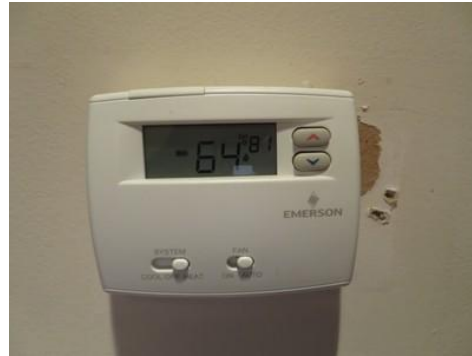
CONTROLS:

The control for the heating and air conditioning system was a 24-volt programmable thermostat located on the hallway of the home. The thermostat was (EMERSON) found to be in working order.
